March 1991

By J. Kunsemiller

## Technical Note

## DEVELOPMENT OF A SEAWATER HYDRAULIC ROCK DRILL

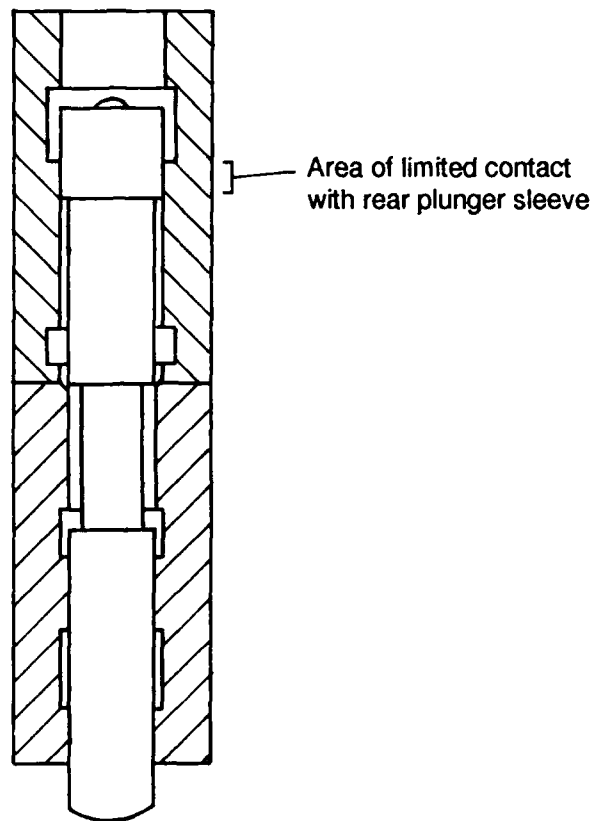
Figure 16. Drive plunger and sleeves layout.

The problem is described as follows and illustrated in Figure 16. The drive plunger is formed by two diameters; a small diameter with an annular cut out midway on its length to facilitate fluid passage between ports, and a larger diameter cap to stop the plunger at the bottom of the stroke. The rear plunger sleeve is bored to the larger diameter and the front plunger sleeve is bored to the small diameter. The sleeves float on O-rings within the housing bore and they are clamped together, crushing the O-ring between them. Under these conditions, the sleeves could move in relation to one another, creating a misalignment of the bore. At the plunger position shown in Figure 16, the contact length between the plunger and the rear sleeve is minimal, which further contributes to misalignment.

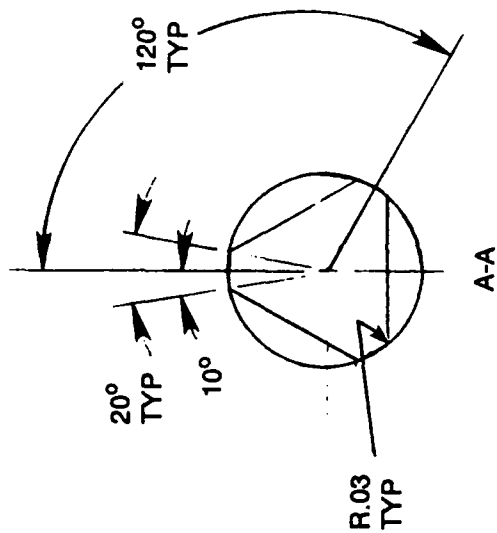
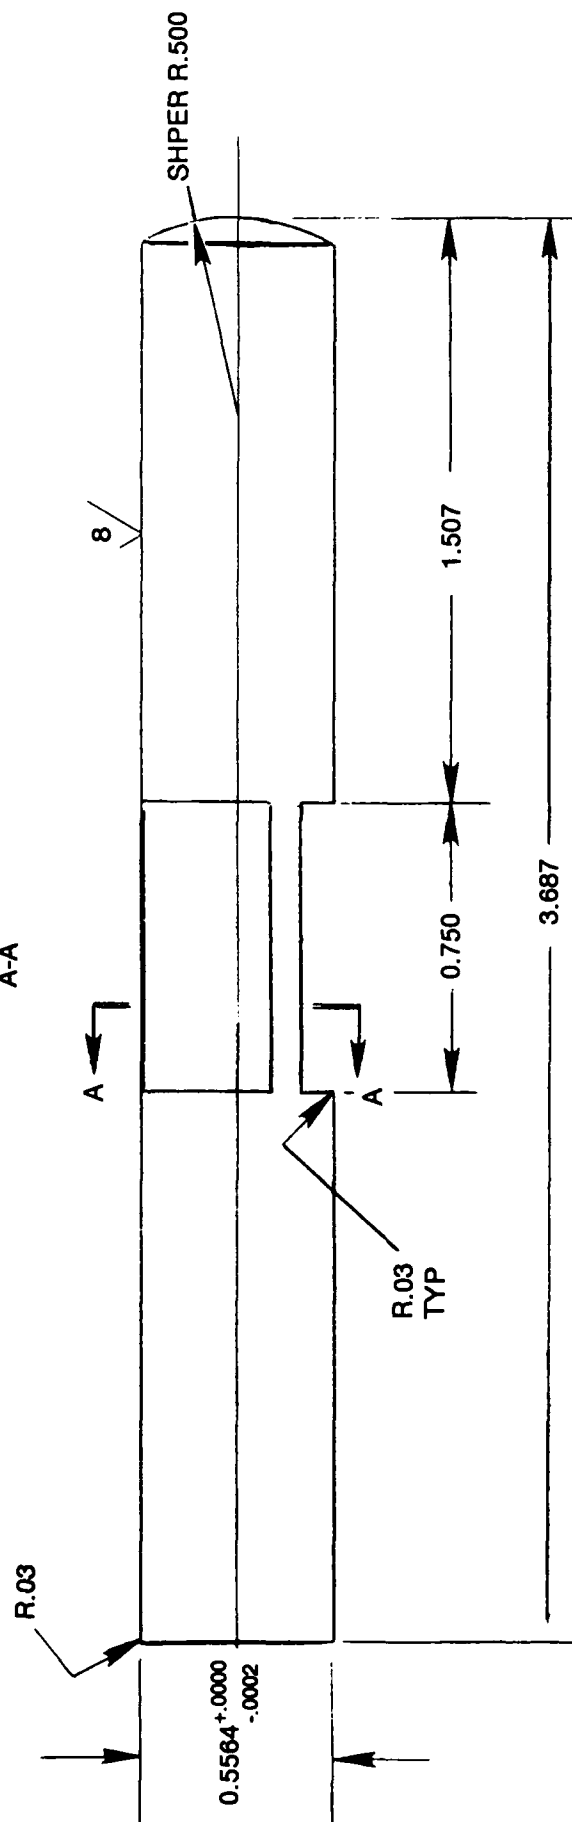
Figure 17. Single diameter drive plunger.

The first attempt to control sleeve alignment, using a plunger of a single diameter, was unsuccessful. The new plunger design, Figure 17, having a single diameter along its length and thin bridge sections at the porting cutout, did not maintain contact with the rear sleeve throughout the stroke. When tested, both the 440C and the MP35N plunger and sleeve pairs failed within a few cycles. The alternative solution was to control alignment with a single sleeve.

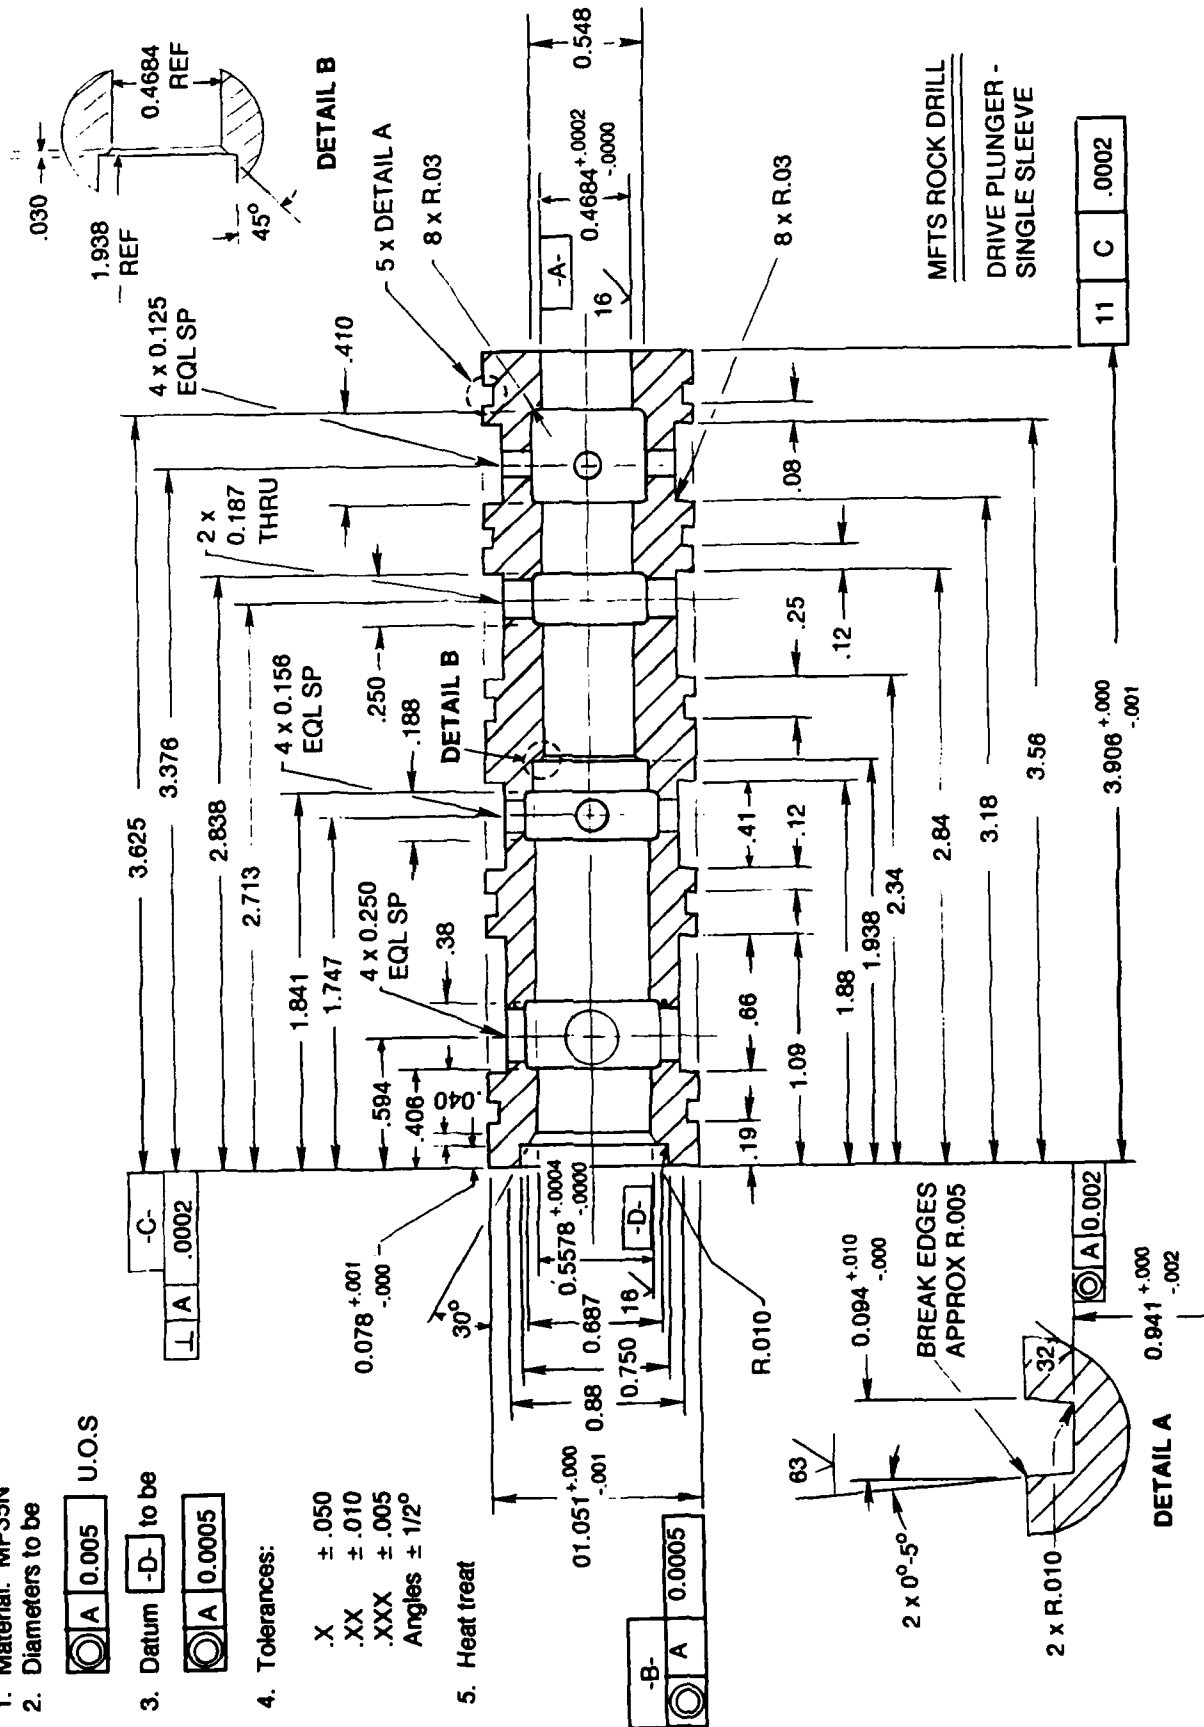
Figure 18. Single sleeve.

A single sleeve, Figure 18, having the original bore profile of two diameters ensured the best possible alignment. This single sleeve was made from MP35N and tested with 440C/ Nedox coated drive plungers. A marked improvement in the integrity of the Nedox coating on the plunger was observed even after 75 minutes of operation. An occasional chip to the coating was caused by the brittle Nedox coating reacting to the impact.

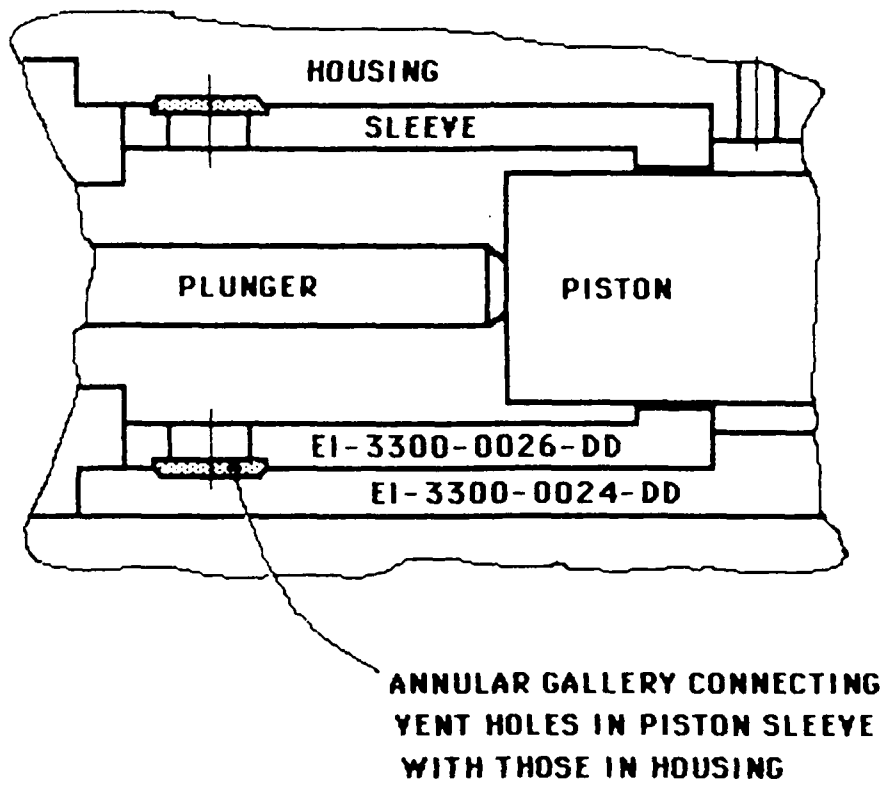
**FIGURE 2**

An oversight in the original ADM design has been repeated in the PPP design as indicated in Figure 2. The annular gallery which is necessary for proper venting of the rear piston face is much too small. As indicated in A-V this will have serious consequences on the net forces which accelerate the piston. Fortunately there is sufficient material in both the housing and the sleeve to correct this deficiency.

The cross holes in the piston housing and the associated piston sleeve serve the purpose of venting the ends of the piston to the ambient. These vents should have a total flow area of the order of the piston cross sectional areas to avoid a head loss from inhibiting the piston motion. The front end is properly vented via four half inch holes directly through the housing. The rear end of the piston, on the other hand, is vented via cross holes in the sleeve insert, an annular gallery and cross holes in the housing. The assembly geometry is shown in Figure 2, and reference to the detail drawings shows that the annular flow area is woefully small. This represents a serious design detail error which was present in the breadboard detail design package as the result of an oversight.

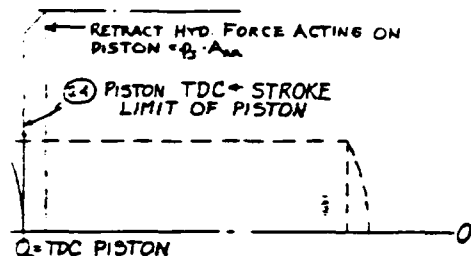
$\Delta x_{rec} = 0.23"$  RANGE OF UNCERTAINTY-  
IF MOMENTUM CARRIED PLUNGER  
1. END INTO CTR BORE (CUSHION) -  $TDC < 0$   
DRIVE CHAMBER COULD BE CUT OFF  
FROM SUPPLY POPPET.  
2. THIS RESULTS IN AMBIGUOUS "START"  
POINT FROM CYCLE TO CYCLE AND  
MAY AFFECT FREQUENCY;  $TDC < x_2 < 0$ ,  
QED.

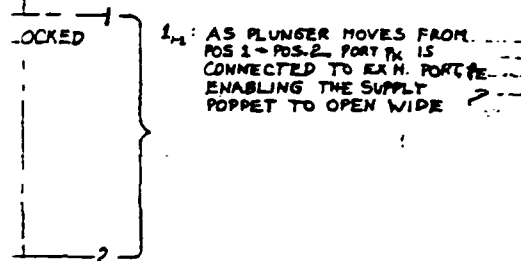
1. @ POS. 3: CLOSING OF EXH. PORT,  $P_e$ , TRAPS  
FLUID IN SUPPLY POPPET SPRING  
CAVITY, EXCEPT FOR LEAKAGE. THIS  
WOULD TEND TO LIMIT  
INLET ORIFICE AT SUPPLY  
POPPET TO WHATEVER  
POSITION IT REACHED AT  
THE TIME PLUNGER  $= x_3$ .  
POINT OF IMPACT  
ON PISTON  
 $\Delta x_{q-4} = 0"$   
 $\Delta x_{rec-4} = 0.23"$   
2. - DUE TO START PT. AMBIGUITY (NOTE: 2.) &  
SUPPLY POPPET RESPONSE UNCERTAINTY  
FREQUENCY MAY BE AFFECTED.
